RI 9242

REPORT OF INVESTIGATIONS/1989

# Surface Fracture Development Over Longwall Panels in South-Central West Virginia

BUREAU OF MINES

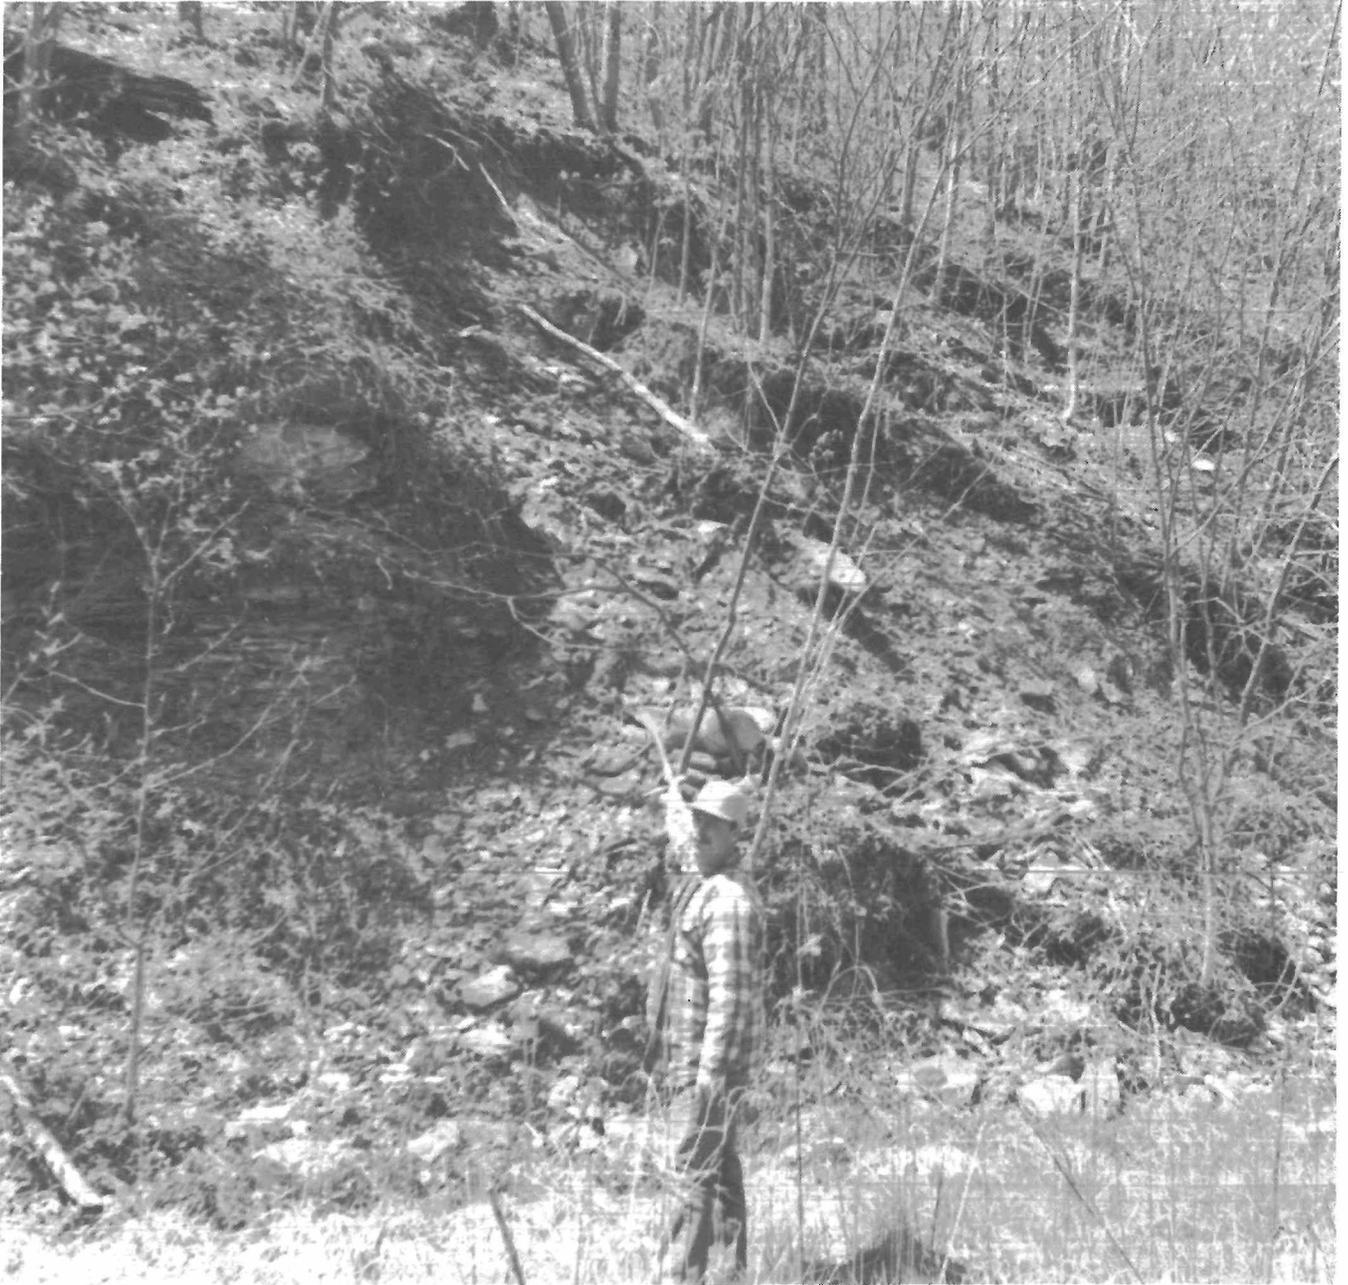
Surface slumping, evidence of a readjustment in the slope stability, was observed along the lower strip mine bench (fig. 13). Several of the slumps had characteristics of being recent. Trees were tilted and freshly exposed soil was observed within the slumps (fig. 14). The older slumps were distinguished from the more recent slumps by occurrence of mature vegetation and vertical trees. Evidence of recent slumping suggests that the fractures could have been influenced by this movement. Slumping may have contributed additional movement during or after the development of the fractures.

**Figure 14.—Recent slump fractures over Mine A.**

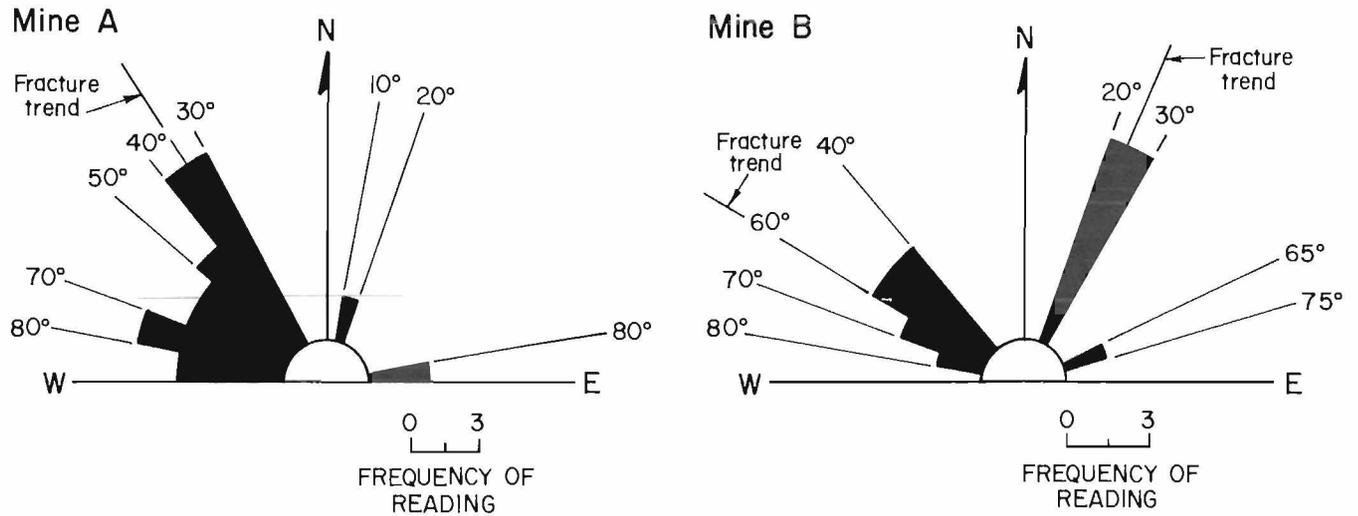
Dominant systematic fracture or joint trends were measured at rock outcrops at several different locations over Mines A and B. Outcrop measurements of joints over Mine A indicate a systematic trend oriented northwest to southeast (fig. 17). The fractures and the longwall panels at Mine A align with this northwest-southeast trend. Outcrop measurements of joints over Mine B indicate two systematic trends (fig. 17). One trend is oriented northwest to southeast, the other is oriented north-northeast to

south-southwest. Unlike Mine A, only the fractures align with these joint trends at Mine B. The longwall panels are oriented about 35° (N 87 W) west of the northwest to southeast joint trend. The two paralleling fractures over or near the longwall gate entries align with the northwest to southeast joint trend. The single fracture situated over the center of longwall panel aligns with the north-northeast to south-southwest joint trend.

Figure 17.—Rosette diagram of fracture measurements in rock outcrops on surface near fractures at Mines A and B.

triggered by longwall mining, then modification in mine layout could be used to control their occurrence. Longwall panels should be oriented 45° to the orientation of the local dominant joint trends. However, orienting panels 45° to joint trends could be difficult if there were several different joint trends occurring in the same local area. Such is the case in southern West Virginia.
